# GCL serves as cap in Brownfield remediation site

New Jersey Brownfield Remediation

Patterson, New Jersey

BENTOMAT® SDN

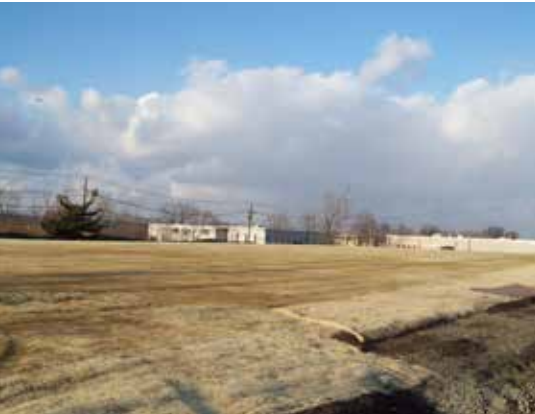
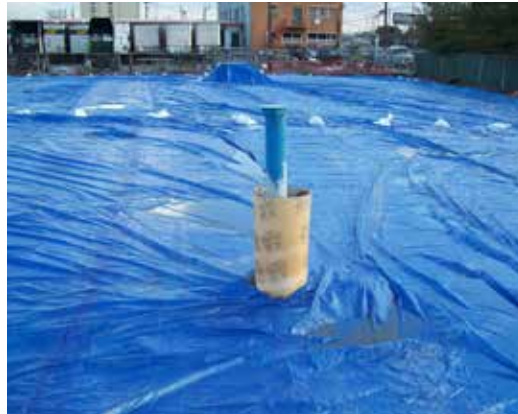
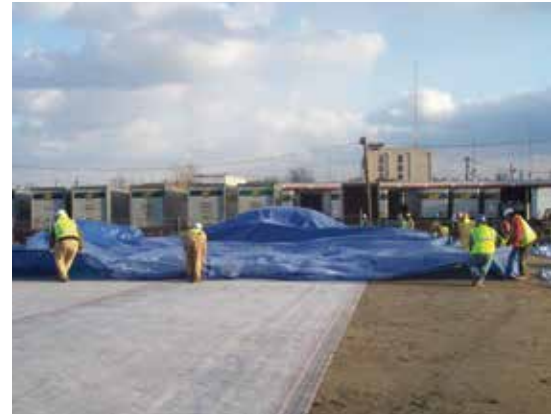
This New Jersey Brownfield was formerly the site of a chemical recycling facility.

The site was surrounded with a soil-bentonite slurry wall and topped with a six-acre geosynthetic cap. The geosynthetics were terminated at a corrugated sheet pile wall. Cast-in-place concrete with an embedded polyethylene strip was added to which the LLDPE geomembrane was welded. The BENTOMAT SDN liner held up well in the high winds.
