Vapor mitigation system maintains construction schedule in cold weather

Springhill Suites

Ridley, Pennsylvania, USA

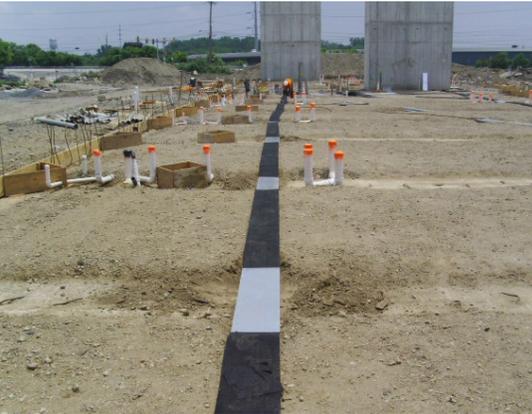
Images left to right: GEOVENT™ trenchless gas venting system being installed directly on the subgrade; LIQUID BOOT® vapor barrier conforms to irregular surfaces and can be applied in the most challenging conditions; LIQUID BOOT® spray-application effectively and effortlessly seals around crucial areas, such as pipe penetrations.
