PROJECT CASE STUDY

High-performance geomembrane with EVOH technology part of gas vapor mitigation solution

Chick-Fil-A

Fort Worth, Texas, USA

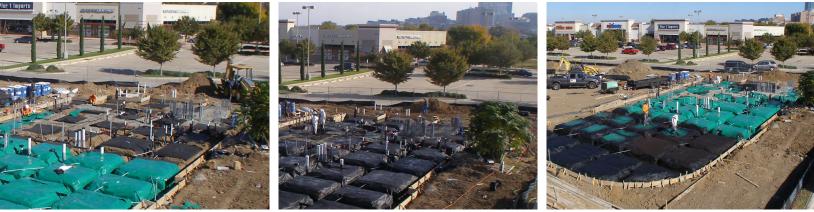
Images (left to right): Installation of the VI-20™ geomembrane with EVOH technology over the low-profile GEOVENT™ gas venting system; fininshed installation of the LIQUID BOOT[®] spray-applied vapor barrier over the VI-20™ geomembrane; in-progress view of the spray-applied barrier being installed over the geomembrane.

The LIQUID BOOT[®] PLUS spray-applied vapor barrier was installed with a low profile venting system. With the understanding that the client is extremely conscientious when creating a quality work environment and visiting space for customers, it was decided that the LIQUID BOOT[®] PLUS vapor barrier with its superior resistance to VOC vapors, would be the best product for this location. LIQUID BOOT[®] PLUS vapor barrier incorporates CETCO's GEOVENT[™] low-profile venting system, VI-20[™] composite geomembrane (green material in images), CETCO's LIQUID BOOT[®] spray-applied membrane and UltraShield[™] G-1000 protection course.
