# REACTIVE CORE MAT® installed as NAPL control remedy at Vermont superfund site

Pine Street Canal Superfund Site

Burlington, Vermont, USA

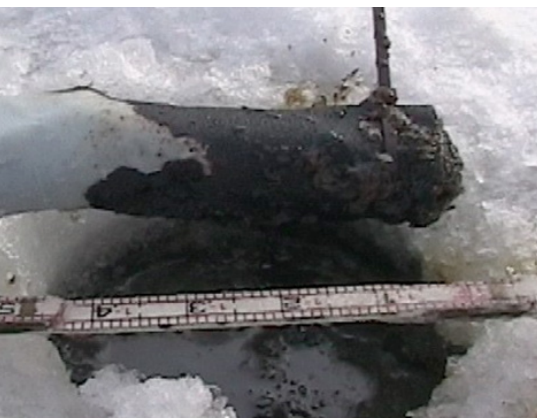
Image left to right: Left – Shows measurable DNAPL on the sand cap surface (Winter 2003/2004). Middle – Surface sheen that was observed after the sand cap installation (2005). Right – ORGANOCLAY filled REACTIVE CORE MAT® being deployed from a barge. Reactive Core Mat® was deployed in multiple layers in some areas.

Nonaqueous-phase liquid (NAPL) was detected on a limited portion of the completed sand cap at the Pine Street Canal Superfund Site. In addition, sheen was observed on the surface of the canal water. Investigations by the active cap design engineer, ARCADIS, revealed that NAPL had migrated through the sand cap due to consolidation and the effects of vertical hydraulic gradients. In 2006, ARCADIS was retained to prepare an Action Plan for development of a revised remedy to control NAPL migration into the Canal.

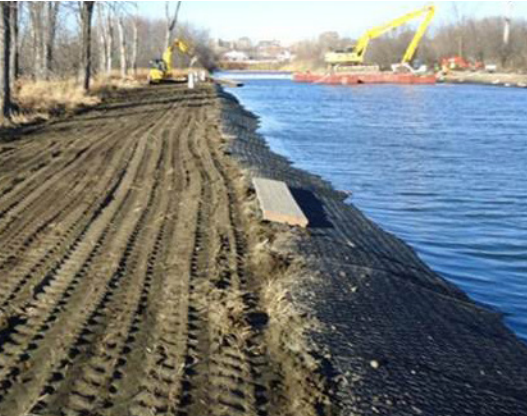
Finished cap.

In 2010, 165,000 square feet of ORGANOCLAY filled REACTIVE CORE MAT® was successfully deployed as an amendment to a portion of the existing sand cap. Historical flooding occurred at the site in Spring 2011. The Final EPA inspection was conducted in August 2011. Since installation, no NAPL seeps have been observed through the amended cap, and all components are stable following flooding.
