CETCO vapor mitigation system chosen as protection for high-profile sports stadium

New York Red Bull Arena
Engineer: Louis Berger Group
General Contractor:
Roberts Construction Group
Certified Installer: EAI, Inc.

LIQUID BOOT® 500
Gas Vapor Mitigation System
GEOVENT™ Gas Venting System

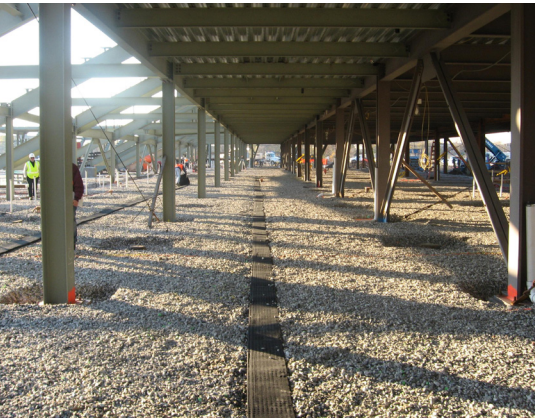
The top left image shows the installation of the GEOVENT™ sub slab venting system. The top right image shows the installed spray-applied gas vapor membrane attaching to the piles themselves and conforming to the haunch. The large image shows how the spray-application allows for quick and air-tight seal around all penetrations and irregularities, saving considerable time and money.

As an approved LIQUID BOOT® applicator, EAI, Inc. installed the GEOVENT™ sub slab venting directly into the stone sub-grade, connecting it to vent risers, which were run up the outside of the stadium. EAI, Inc. also installed 80,000 square feet of LIQUID BOOT® gas vapor barrier to the underslab of the stadium bleachers, sealing directly onto the timber piles and around haunched areas of the foundation. After installation, EAI performed rigorous QA/QC procedures, including a smoke test which pumped smoke underneath the entire membrane, in order to observe for any pinhole leaks. Once any needed repairs were made to the membrane, ensuring a vapor tight seal, the membrane was then protected with ULTRASHIELD™ G-1000 protection course.
