Spray-applied barrier is proven methane mitigation solution on former gas station site

Rite-Aid Pharmacy

Prospect Park, PA

LIQUID BOOT® Gas Vapor Mitigation System

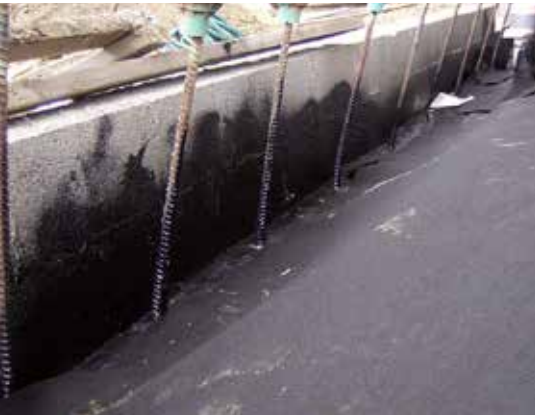
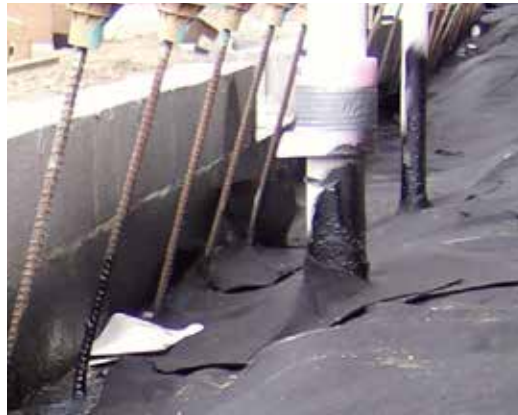
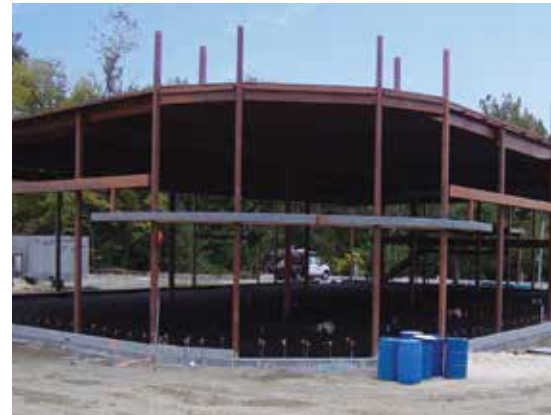
The spray applied application of the LIQUID BOOT® gas vapor barrier ensured the project be completed quickly, and with the application of CETCO's leading quality assurance and control procedures such as smoke testing, CETCO was able to provide a membrane that was ensured vapor tight even with the number of penetrations and foundation complexities.

Actually, the job was made considerably easier and satisfied the engineers wishes that we attach LIQUID BOOT® to the piles themselves rather than on to the pile caps. Only the LIQUID BOOT® spray applied barrier would be able to perform in these haunches. LIQUID BOOT® was also chosen for its superior track history and methane permeability. We were also had a cheaper installation cost than batten and welded HDPE.

In order to obtain building approval, an engineered barrier was required to build the 12,000 square foot pharmacy. Another major concern were the amount of penetrations and the complexities of the foundation design, which would make it difficult to ensure a vapor tight seal around the entire footprint. As stated, only the LIQUID BOOT® system would have been able to be applied in those areas where the membrane had to be haunched down to the piles.
