# Gas vapor mitigation system maintains construction schedule in cold weather

The site of the Springhill Suites Hotel and Restaurant posed potential vapor intrusion concerns due to low-level VOC contaminants found in the soil.

Springhill Suites

Ridley, PA

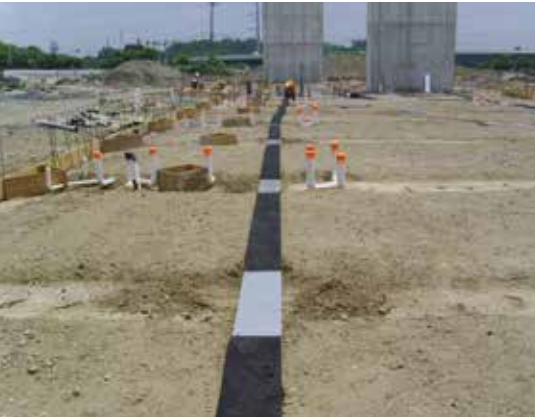
Images left to right: The GEOVENT™ trenchless gas venting system being installed directly on the subgrade (left). LIQUID BOOT® conforms to irregular surfaces and can be applied in the most challenging conditions (middle). LIQUID BOOT® spray-application effectively and effortlessly seals around crucial areas, such as pipe penetrations (right).
